CONCRETE REPAIR BULLETIN

September/October 2025 Vol. 38, No. 5

# PRESERVING THE PAST:

## RESTORATION OF THE 18TH CENTURY CHARLESTON COUNTY HISTORIC COURTHOUSE

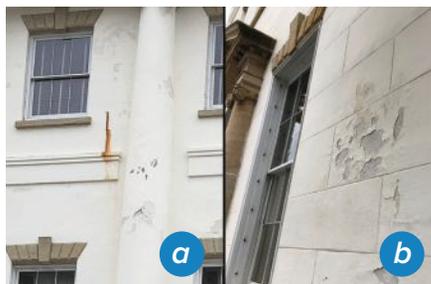
Fig. 3: (a) Examples of stucco, coating and corrosion distress and (b) close-up of coating distress that motivated the county to commission the assessment and evaluation.

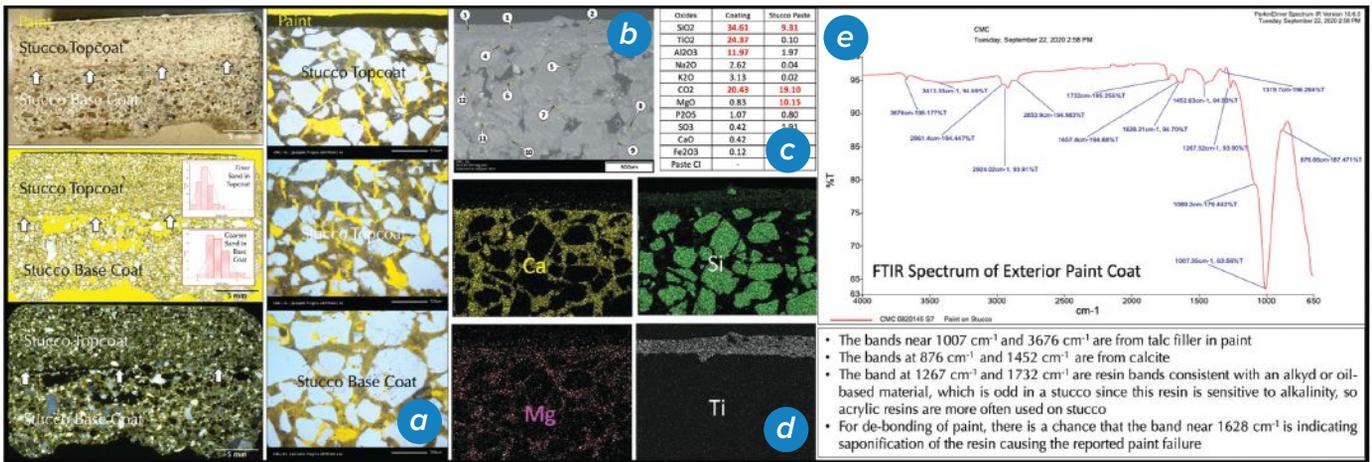
Fig. 8: Examples of analytical images and data representation: (a) sawcut and thin sections, (b) backscatter electron image, (c) x-ray elemental oxide compositional analysis of paste and coating, (d) x-ray elemental maps, and (e) FTIR spectra of paint coating removed from stucco.

Testing showed an alkyd resin-based paint containing titanium oxide pigment and talc filler and underlying two lime mortar layers of crushed silica sand (of noticeably different sand fineness in two layers) and dolomitic hydraulic lime having total stucco thicknesses ranging from 5/8 to 7/8 inch (16 to 22 mm). Alkyd components within the coatings are well-known to be susceptible to deterioration when used on cementitious materials in the presence of moisture. Evidence was identified for three potential causes for coating failures.

1. Application of a pH-sensitive alkyd resin-based paint coat on a lime mortar base. FTIR studies found evidence of possible saponification of resin as a potential cause for peeling from the substrate.
2. Possible soft and dusty lime-based substrates with associated poor coating adhesion.
3. Potential excessive drying shrinkage from noticeably finer crushed silica sand in the stucco layer beneath coatings, which is seen from more severe shrinkage microcracks in that layer.

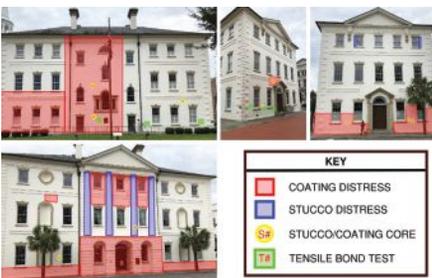
Fig. 6: Identified stucco and coating distress, and test locations.

**Site Observations and Sampling Locations**  
Coating distress was largely observed at mass masonry substrates and where previous patches were installed and moisture levels were elevated. A previously repaired area with reinforced masonry substrate displayed significantly less coating distress, likely due to implemented modern waterproofing practices.

Stucco delaminations were located by sounding with a nonmetallic hammer per recommendations in Preservation Brief 22.<sup>17</sup> Delaminations believed to be in danger of detachment were removed by the assisting contractor during the investigation. Like the coatings, stucco delamination was most readily identifiable where mass masonry substrate exists, where portland cement patches were previously installed, and where elevated moisture levels were detected. Variable stucco thickness was identified across each elevation and was confirmed via cores. Figure 6 shows observed coating and stucco distress, as well as sampling locations for coatings and laboratory analysis.

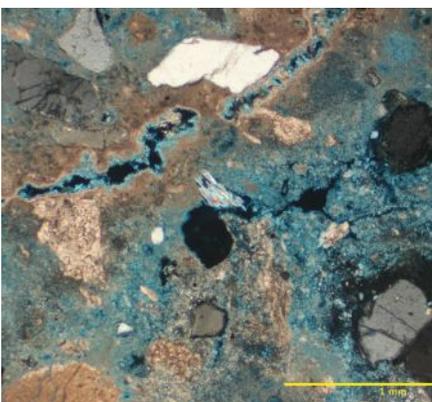
Fig. 7: Cross-polarized light image of the 18th century foundation bedding mortar containing oyster shell, quartz sand and carbonated lime grains.

Petrographic analysis was conducted on a foundation bedding mortar sample, identifying the mortar as an oyster shell lime typical of 18th century Charleston construction. Petrographic findings correlated with archival resources to indicate that the Provincial Statehouse foundation was reused for construction of the Historic Courthouse.

Cores from all sampling locations verified archival and project record data by displaying a specific and unique chronology of repairs across all core samples. Specifically, traces of the original 19th century stucco were retained at the base of the samples, showing that the original render had been removed during earlier repair campaigns. The 2000 restoration stucco was well represented in each core, and the composition approximately matched the original project specifications. Figure 7 shows an example of cross-polarized light image of embedment mortar.

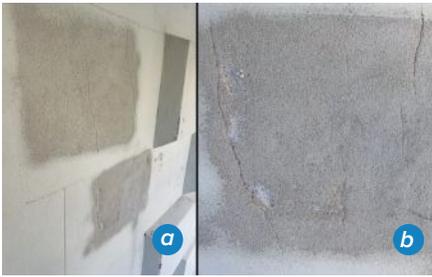
Fig. 10: Coating removal mock-up to demonstrate removal method: (a) overview of test areas and (b) surface after removal with minimal stucco damage.

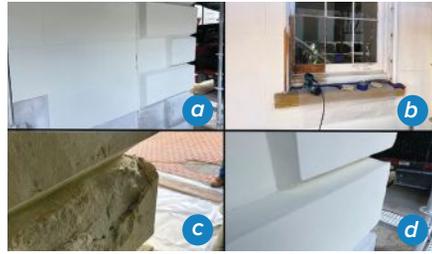
Fig. 11: Stucco and window restoration mock-ups: (a and b) overviews; (c and d) preexisting condition with severe stucco damage and demonstrated aesthetic through mock-up.

County representatives, the city architect, BAR representatives, historic societies' representatives, engineers, conservators and contractor personnel attended mock-ups to confirm approaches and aesthetics. Of considerable importance to historic preservation stakeholders was minimizing replacements and limiting impact only to necessary areas and components. Chemical stripping of existing coatings was specified. However, the contractor was able to demonstrate tight control of limestone-based sandblasting with pressures carefully maintained for adequate removal and surface profiling, but minimal damage to soft stucco substrate (Fig. 10). Stucco and coating replacement mock-ups were required to demonstrate the profiling and aesthetic of the new mineral silicate coating system (Fig. 11). Heat-based and chemical-based stripping of coatings on wood windows were evaluated in the mock-up. Chemical stripping was ultimately used on the project due to ease of use and construction schedule. Mock-ups of the capital and console repairs were also carefully coordinated with the conservator, owner and product experts to select the proper repair mortar and color for the historical architectural features.

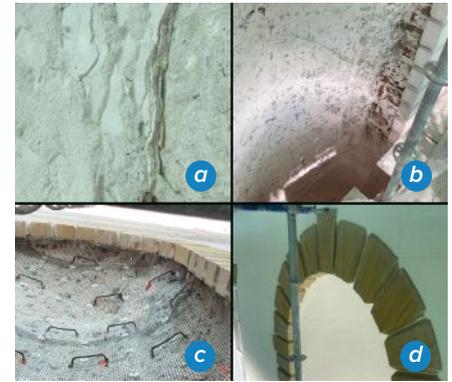
During tactile removal and in-depth evaluation of stucco damage during construction, it became apparent that more areas included defective sublayers than originally thought based on representative testing. Although the harder exterior stucco layer was intact in many locations, softer layers beneath exhibited deterioration and powdery material with poor adherence to mass masonry substrate and poor suitability for receiving new overlying stucco. Thus, additional stucco replacement was elected, consistent with the areas of coating distress, elevated moisture and sheathing substrate such as gable roof surfaces and chimney walls.

Fig. 12: Stucco: (a) deterioration, (b) conditions after removal to brick substrate, (c) example of reinforcement where thicker stucco conditions were encountered and (d) area after repairs. Note: Photos of similar areas.

replacement. This was particularly evident at niches and belts. Niches had significant coating and stucco deterioration with up to 8 inches of unsupported stucco, distinct layers of variable delamination and periodic portland cement-based patches. To support new stucco, intermediate layers of composite mesh were installed and fastened to threaded "U" pins anchored into the existing mortar bed (Fig. 12).

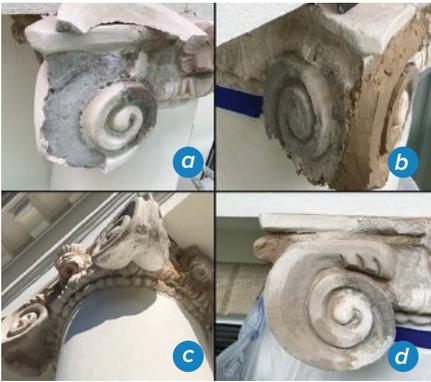
Fig. 13: Ornamental components: examples of (a) damage, (b) molded repair material after placement, (c) overview after shaving repair material and (d) close-up after repair.

Local damage to sandstone capitals and consoles with intricate details was identified that required repair. Portions of these features are believed to date back to the 18th century construction; however, numerous repairs had been conducted with varying material color and composition. Cast repair mortars, carved sandstone replacements and molded-in-place repairs were considered. Molded-in-place repairs were selected due to the construction schedule and skilled labor available (Fig. 13).
