CONCRETE REPAIR BULLETIN

September/October 2025 Vol. 38, No. 5

# PRESERVING THE PAST:

## RESTORATION OF THE 18TH CENTURY CHARLESTON COUNTY HISTORIC COURTHOUSE

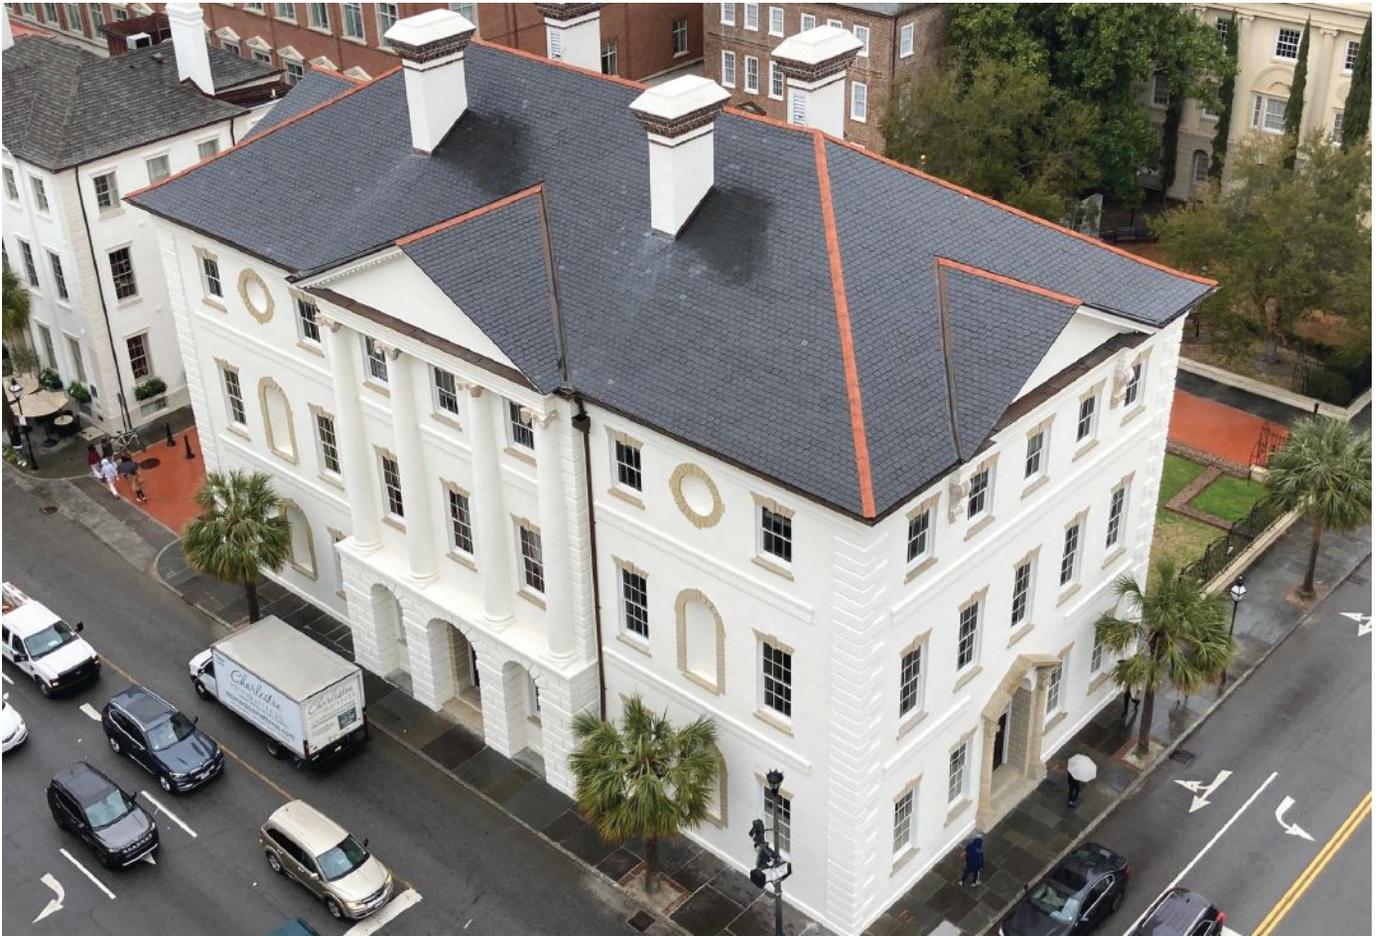
*Fig. 1: Charleston County Courthouse as viewed March 2025, after rehabilitation, from the steeple at St. Michael's Episcopal Church on the corner of Broad and Meeting streets.*

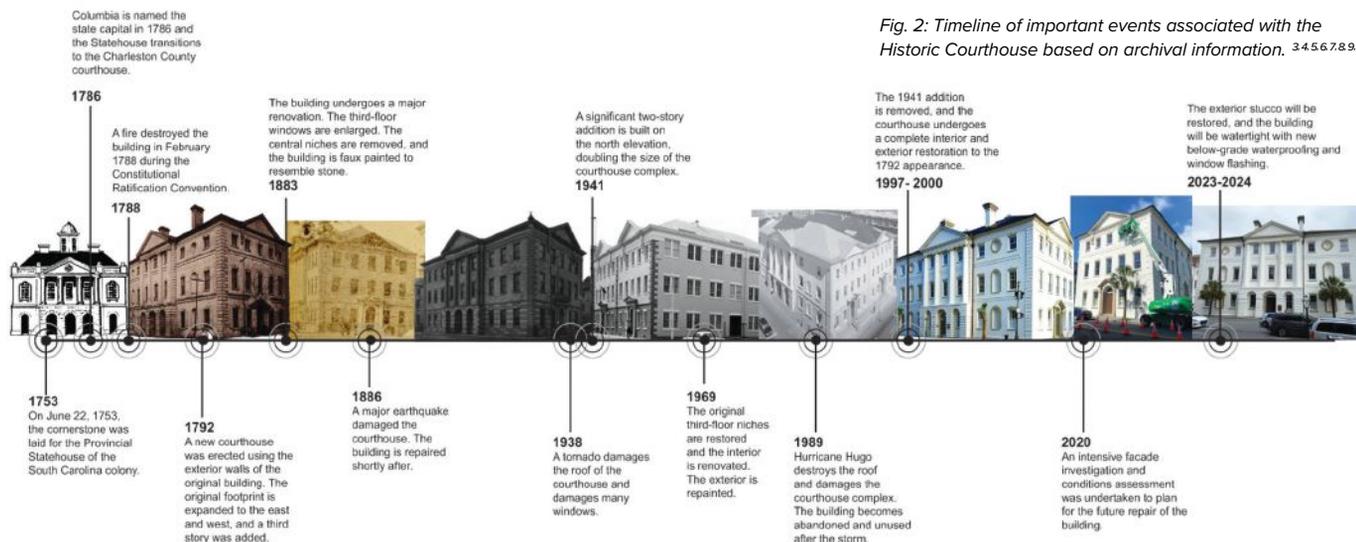
Throughout its nearly 250-year existence, the Courthouse has experienced natural disasters, transformations, and repair and restoration projects that have shaped its current state (Fig. 2). Since the large renovation project in 2000 to bring the Courthouse back to its 1792 appearance, the county observed progressive deterioration in the façade, including spalling stucco, corrosion of inserts and coating failures (Fig. 3). Numerous hurricane protection anchor points, critical to protection systems deployed annually or more frequently, had failed. While public safety is of primary concern to the county, Charleston County Facilities Department is also responsible for preserving the aesthetic and function of the Historic Courthouse for the benefit of current and future generations. Thus, the county sought an

Fig. 2: Timeline of important events associated with the Historic Courthouse based on archival information. 3,4,5,6,7,8,9,10

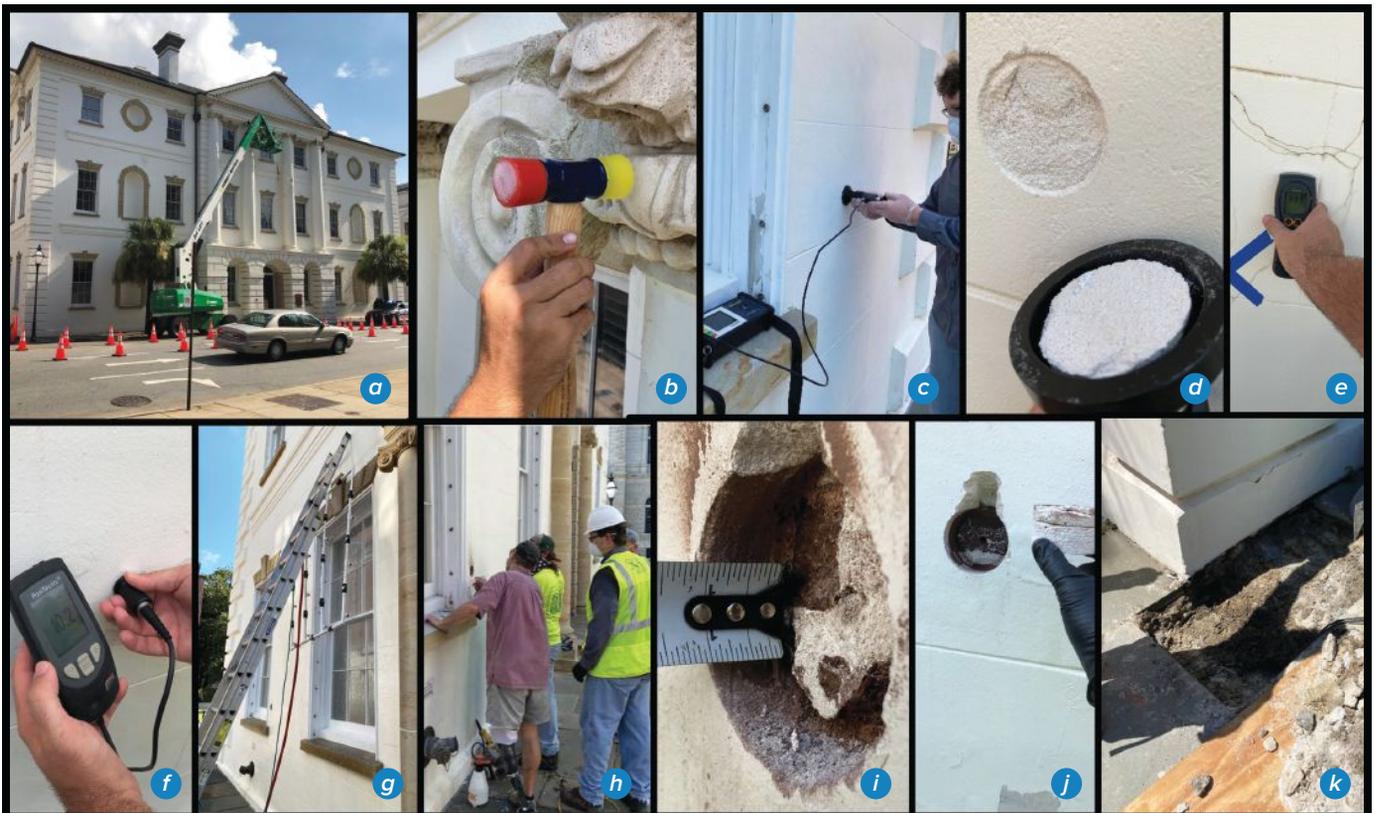
Fig. 5: Site testing: (a) general overview of assessment, (b) sounding of surfaces, (c) coating adhesion testing, (d) coating adhesion testing failure mechanisms, (e) radio frequency moisture testing, (f) coating thickness testing, (g) window leak testing, (h) surface review, (i) measurement of stucco thickness, (j) core sample and (k) below-grade excavation.

samples were extracted for materials testing. Nondestructive testing by sounding was conducted on representative portions of the façade, with nonmetallic hammer and water testing implemented on selected windows. Façade coatings and stucco conditions were evaluated using physical thickness measurements and nondestructive ultrasonic coating thickness testing, radio frequency moisture detection as generally described in SSPC-Guide 23,<sup>13</sup> and tensile bond strength testing in general accordance with ASTM D7234.<sup>14</sup>

A mortar sample was evaluated per ASTM C1324,<sup>15</sup> and multiple coated stucco samples were evaluated per ASTM C856<sup>16</sup> and other advanced analytical techniques. A below-grade excavation was also conducted to investigate any previous waterproofing and conduct further masonry testing. Supplemental hazardous materials testing by an environmental subconsultant revealed no asbestos or lead in the areas planned for restoration. Figure 5 shows photos representing site testing and sample procurement.

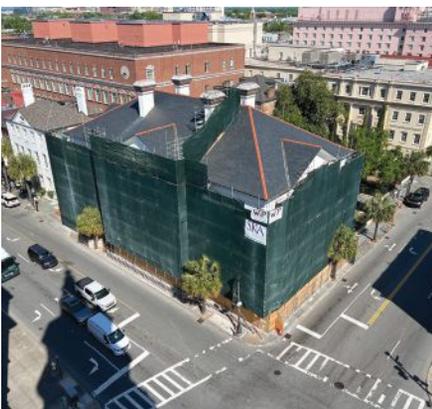
Fig. 9: Courthouse, as photographed in 2024 with screening during restoration.

Restoration activities for the \$2.5 million project were conducted between December 2023 and February 2025. Scaffolding and screening were erected along the entire building (Fig. 9). The building and adjacent streets remained open, requiring sidewalk protection and dedicated entry access. Two named storms, Debbie in August 2024 and Helene in September 2024, required alteration of protection to account for high winds and heavy precipitation. Temporary removal of historic bluestone surrounding the Courthouse required meticulous identification for

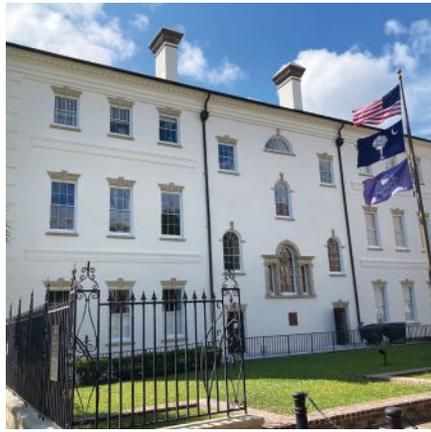
A comprehensive, team-focused approach was used to evaluate safety concerns and restore the Charleston County Historic Courthouse (Fig. 14). Archival research from various sources proved helpful for supplementing field and laboratory data and gaining vital perspective on the physical evolution of the building. A thorough understanding of the building's physical history, stucco and coating distress mechanisms and current conditions allowed the owner and design team to effectively plan restoration. Challenges during construction included those associated with maintaining public access, implementing current technology while honoring historic values and minimizing impact to the building, and correction of unforeseen conditions that arose during construction. Collaboration by the owner (Charleston County), design and evaluation team (restoration engineers,

Fig. 14: Courthouse in March 2025 after restoration.
